The lake dropped more in 2014 than in prior years, partly due to lowering the lake by about 8" in June to get rid of invasive weeds. This must be done every few years to prevent the lake from becoming choked with weeds. An unusually dry summer aggravated the problem.

The unusually low level of Lake Massapoag last summer continued a long-term downward trend that can be seen in the lake level data from 1998 through 2013. The median daily level of Lake Massapoag in August and September was about 4" lower during the 8-year period from 2006 through 2013 than it was during the 8-year period from 1998 through 2005.

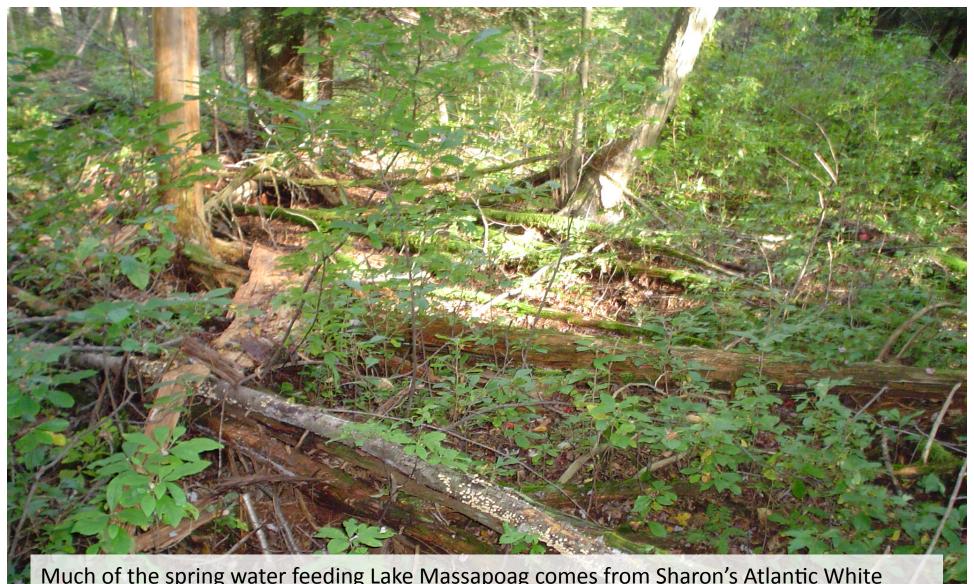
Much of the spring water feeding Lake Massapoag comes from Sharon's Atlantic White Cedar Swamp, as well as much of the base flow in Beaver Brook, which provides about 60% of the town's drinking water. Sharon's Atlantic White Cedar Swamp is drying out, as evidenced by hundreds of dead and fallen cedars. Encroachment of upland vegetation accelerates evapotranspiration.

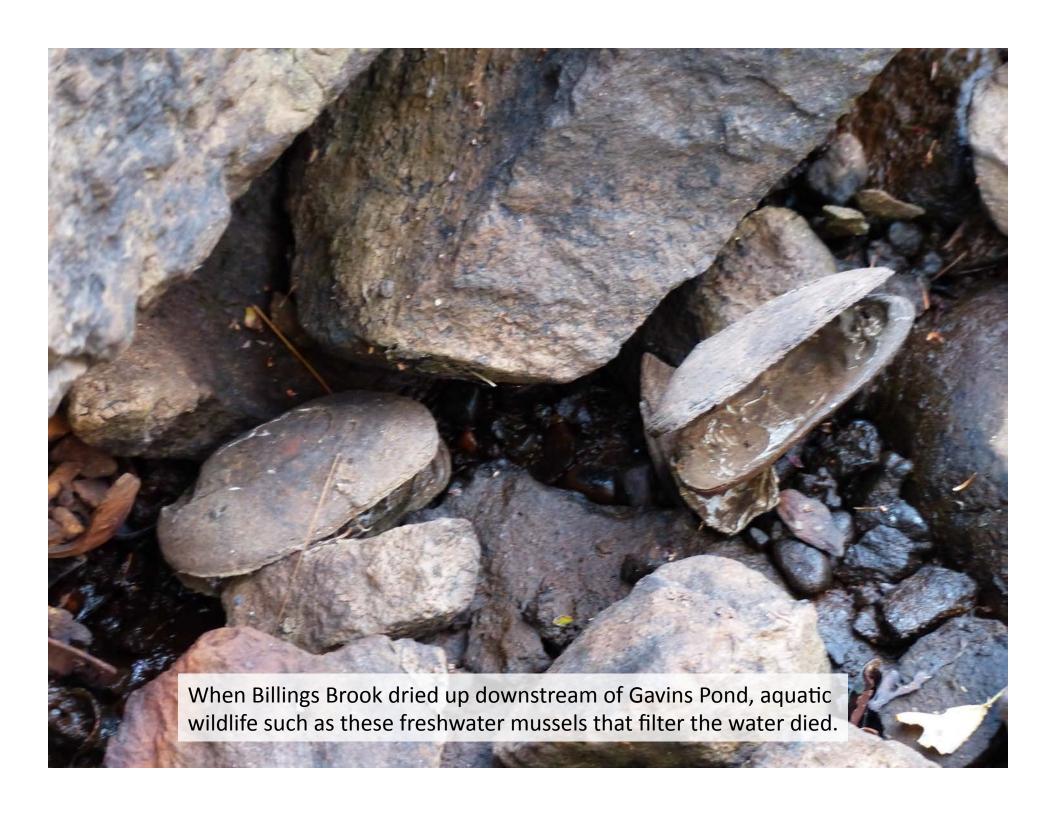
Billings Brook stopped flowing downstream of Well #7 in late summer and fall, 2014.

Slides 13 and 14: Daily flow data from www.rifls.org.

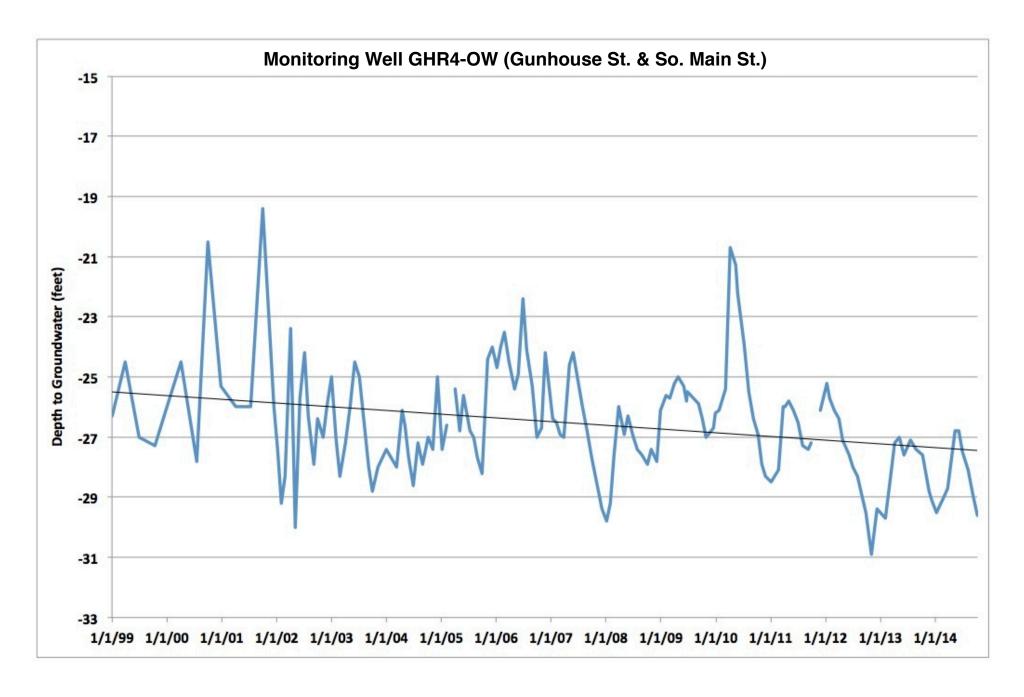
Graphs of monitoring well data have been presented at public meetings in Sharon to show that there has been no trend in the water table in Sharon since monitoring began in 1999.

Slides 17, 18 & 19: Monitoring well observations by Sharon DPW.

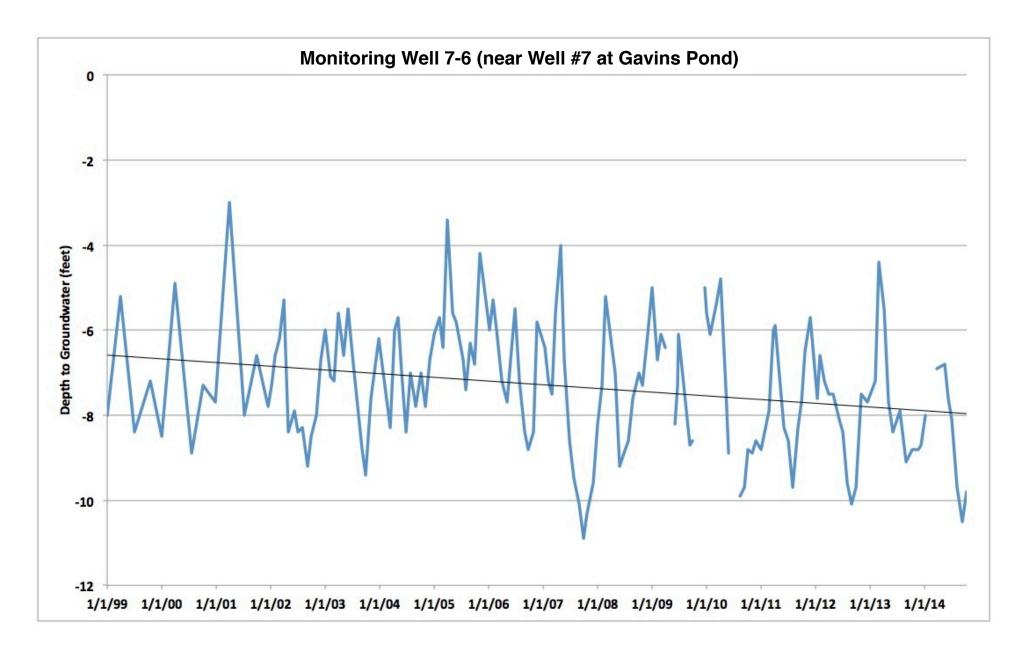
However, upon closer inspection, data from some monitoring wells do show a downward trend.
